Manhole Inspection Summary

Manhole # S19W__027MH

Insp Date: **7/1/08 8:48 AM**

Location Address: **2308 monterey st**

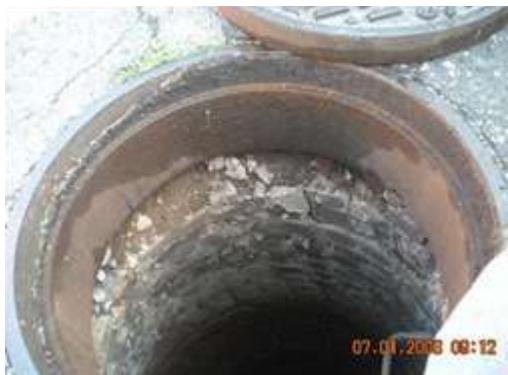
Sheeting Evidence

Subject To Ponding: **Sheeting**

inflow evidence from sheeting

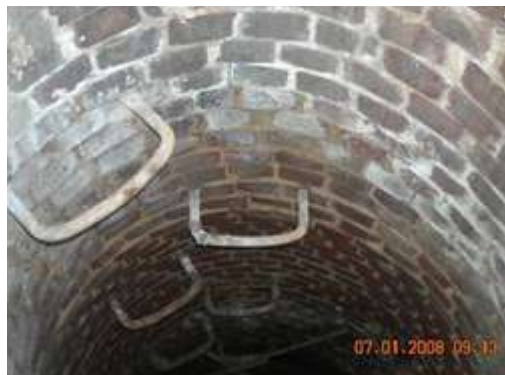
Defect 6

Infiltration: ☐ None ☐ Joint ☐ Cracks ☐ Mortar ☐ Roots ☒ **Wall**

infiltration @ corbel wall

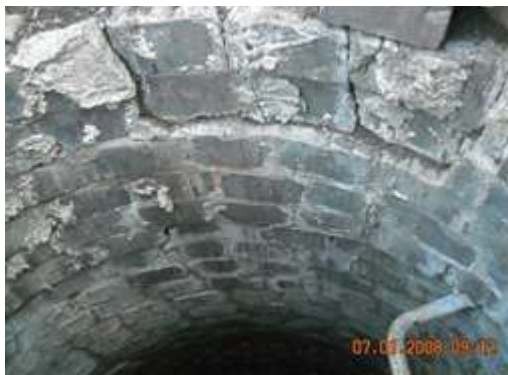
Defect 4

Condition: ☐ Sound ☒ **Cracked** ☐ Root Intrusion ☒ **Loose Brick** ☐ Deteriorated

cracked and loose corbel bricks

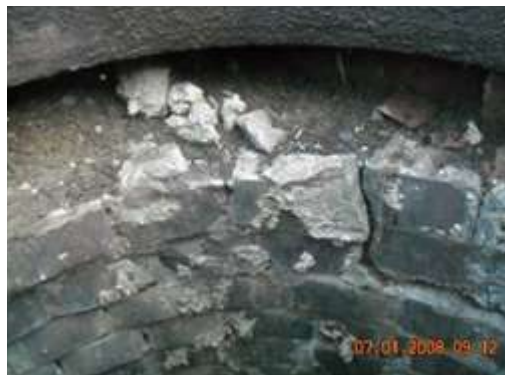
Defect 3

Condition: ☐ Sound ☒ **Cracked** ☐ Root Intrusion ☒ **Loose Brick** ☒ **Deteriorated**

cracked, loose bricks and deteriorated chimney

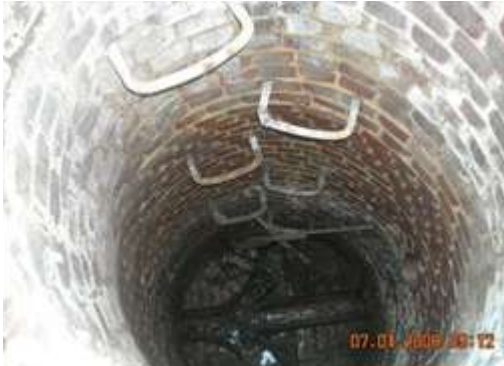
Defect 2

Count: **7** Missing: **0** ☒ **Corroded**

corroded steps

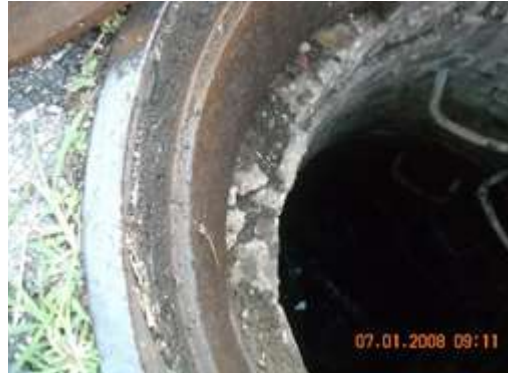
Defect 1

Offset: **2** (in.)

frame offset
